**Flood Control Project Maintenance  
Levee Inspections**  
**LMA District Cover Sheet**  
**Spring 2017 Levee Inspection Results**

**Reclamation District No. 0501 Ryer Island**

**Spring 2017 Levee Inspection Results**

**Levee Inspection Report By Mile - Spring 2017**

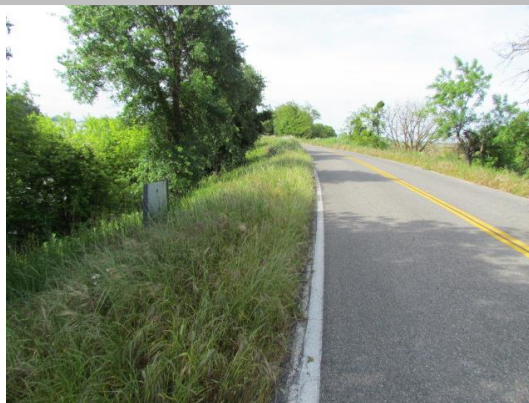
Photo 1 of 1 : SP\_2017\_RD0501\_169\_44\_20170522\_00058.jpg

LM Start	0.04	Rating **	M	Issue No.	44
LM End	2.81	Issue Type +	Ma	Location *	WS
Category	Earthen Levee			GPS Latitude/Longitude	
				Start	End
Item	Vegetation			38.254035 °	38.215490 °
				-121.601790 °	-121.607930 °
DWR ID	DWR_RD0501_01_f_2016_44				
Comment Code					
V1 : Control annual grass and weeds on the levee slopes and easements.					
Inspector Comment					
Control the annual grasses and weeds from the levee slope.

RD 501 Unit 1 looking downstream from levee 0.04 waterside.

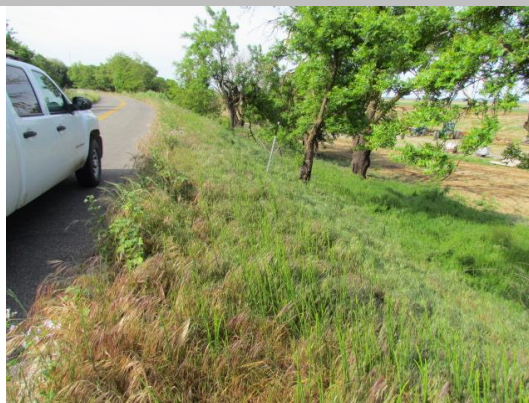
Photo 1 of 1 : SP\_2017\_RD0501\_169\_42\_20170522\_00059.jpg

LM Start	0.04	Rating **	U	Issue No.	42
LM End	6.16	Issue Type +	Ma	Location *	LS
Category	Earthen Levee			GPS Latitude/Longitude	
				Start	End
Item	Vegetation			38.254035 °	38.185987 °
				-121.601790 °	-121.648192 °
DWR ID	DWR_RD0501_01_f_2016_42				
Comment Code					
V1 : Control annual grass and weeds on the levee slopes and easements.					
Inspector Comment					
Control the annual grasses and weeds from the landside slope.

RD 501 Unit 1 looking downstream from the landside slope.

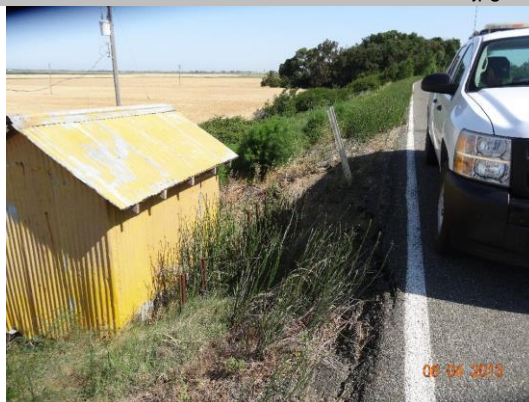
Photo 2 of 3 : UCIP\_SP\_2017\_32524\_58927.jpg

LM Start	0.39	Rating **	M	Issue No.	981
LM End	0.39	Issue Type +	En	Location *	LS
Category	Supplemental			GPS Latitude/Longitude	
				Start	End
Item	DWR UCIP Field Study			38.249197 °	38.249197 °
				-121.603061 °	-121.603061 °
DWR ID					
Comment Code					
Inspector Comment					
FS_ID:32524 DS_ID:21031 EP_NO: N/A Repair Type: Non-Urgent Crossing Status: Found UCIP Comments: Dense vegetation limits the inspector's visibility to identify signs of leaks through the slope. Recommend removing vegetation along pipe alignment for reinspection. Need to contact the owner to clear slope along crossing. FIELD_STRUCT_DESC: 20-inch and 2.5-inch pipes through the levee, both 7.8 feet below the crown. Pump in pump house on landward slope. Pipe exposed along waterward slope. (USACE-1959). This entry matches the Drainage or Irrigation Structure referenced in O&M manual (HLM 0.40). FS Date: 6/4/2013

Overview of landside. Pump house and power pole visible on landward side.

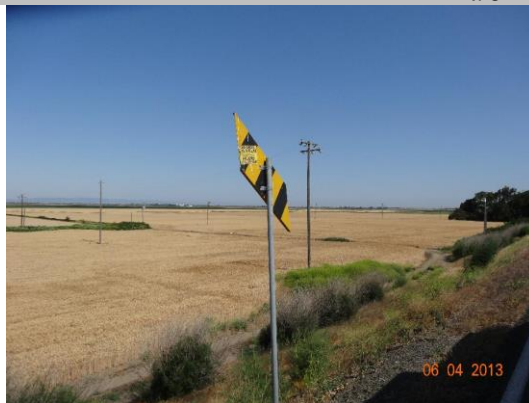
Photo 2 of 3 : UCIP\_SP\_2017\_41409\_58930.jpg

LM Start	0.44	Rating **	M	Issue No.	982 (cont)	
LM End	0.44	Issue Type +	En	Location *	LS	
Category	Supplemental			GPS Latitude/Longitude		
				Start		End
Item	DWR UCIP Field Study			38.248519 °		38.248519 °
				-121.602972 °		-121.602972 °
DWR ID						
Comment Code						
Inspector Comment						
FS_ID:41409						
DS_ID:21032						
EP_NO: N/A						
Repair Type: Non-Urgent						
Crossing Status: Found						
UCIP Comments: Need to contact owner and ask for emergency						
contact infomation and permit number. 8/21/13 Contacted Gas						
Control Division under the emergency contact No. 1-877-723-3344.						
Message has been forward to Brian Habersack at 916-859-4700, email:						
bhabersack@gasbiz.com.						
FIELD_STRUCT_DESC: 6-inch Steel Gas line through the levee 60-						
feet below the crown. Markers on both shoulders (Permit No. 17033,						
2014).						
FS Date: 6/4/2013

Overview of landside at crossing. Marker on shoulder.

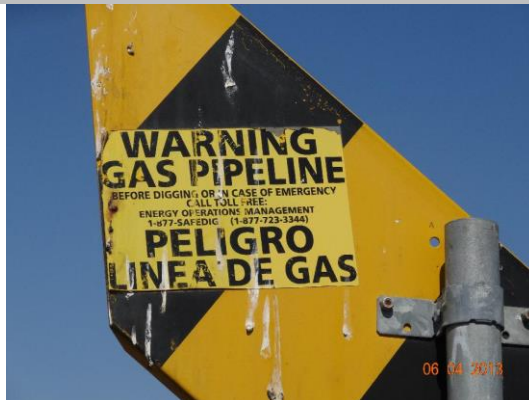
Photo 3 of 3 : UCIP\_SP\_2017\_41409\_58932.jpg

Gas line contact information on the sign.

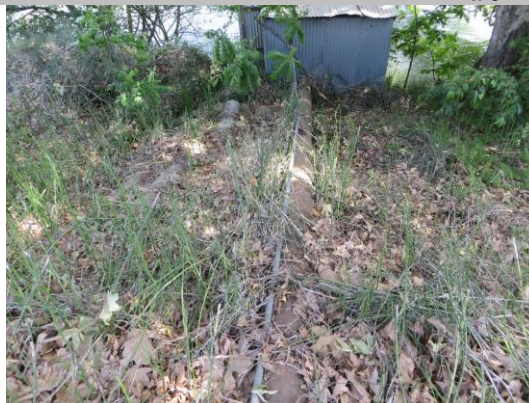
Photo 2 of 3 : UCIP\_SP\_2017\_44683\_73881.jpg

FS\_ID:44683  
DS\_ID:21021  
EP\_NO: N/A  
Repair Type: Non-Urgent  
Crossing Status: Found  
UCIP Comments: Appears abandoned and if so should be done so properly. Discarded pipe on WS slope should be removed.  
FIELD\_STRUCT\_DESC: 10-inch steel irrigation pipe through the levee, 2.5-feet below the crown. Pump and gate valve in pump house on waterward slope. a 4'X4' concrete distribution box, power pole, and meter on LS toe (USACE-1959). This entry matches the Drainage or Irrigation Structure referenced in O&M manual (HLM 2.50).  
FS Date: 4/21/2015

Pipe and pumphouse on WS slope.

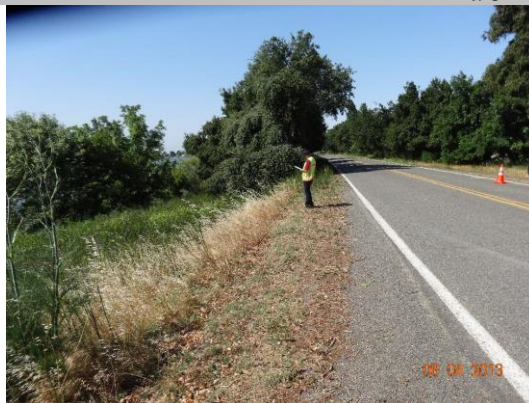
Photo 1 of 3 : UCIP\_SP\_2017\_32526\_58933.jpg

UCIP Comments: Dense vegetation limits the inspector's visibility to identify signs of pipe failure (leaks) through the levee slopes. Recommend removing vegetation along pipe alignment to conduct proper inspection of structure and appurtenances. Additional notes: pump was running during inspection, 16-inch pipe debris section located on landward side, view of standpipe and support structure on waterward side does not match structure description--need to determine if crossing has been altered.

Overview of crown at crossing, looking downstream.

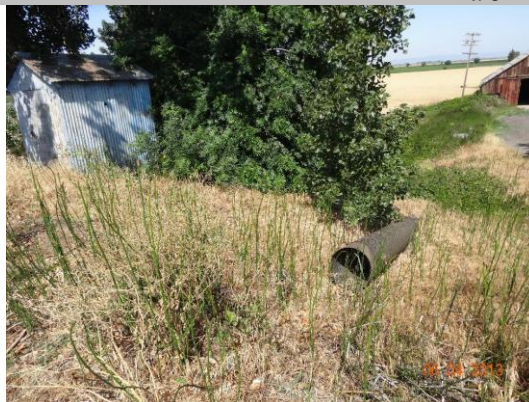
Photo 2 of 3 : UCIP\_SP\_2017\_32526\_58935.jpg

Pump house on landward slope. An abandoned pipe section on landward slope.

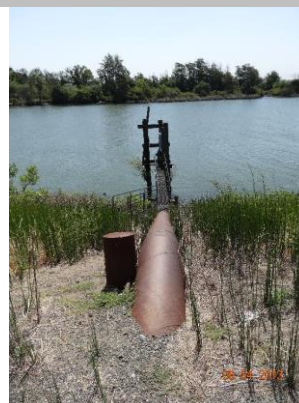
Photo 2 of 3 : UCIP\_SP\_2017\_32529\_58951.jpg

View of waterward side--siphon breaker, walkway, platform, pump, and control panel.

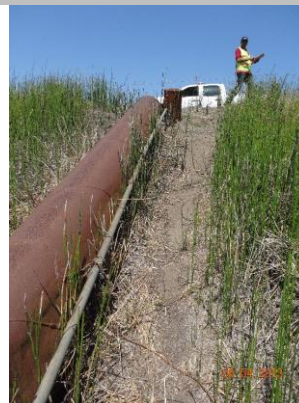
Photo 3 of 3 : UCIP\_SP\_2017\_32529\_58952.jpg

20-inch steel pipe along with 1.5-inch electrical conduit on landward side.

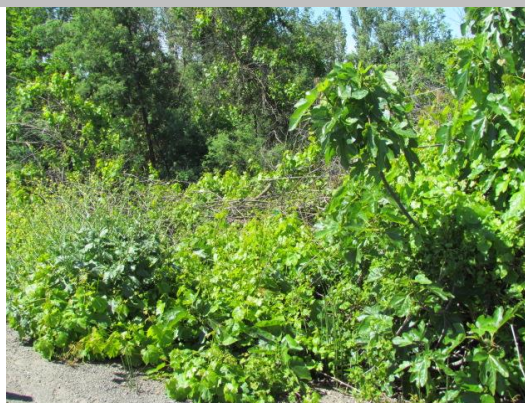
Photo 1 of 1 : SP\_2017\_RD0501\_169\_974\_20170522\_00062.jpg

LM Start	3.73	Rating **	U	Issue No.	974
LM End	4.12	Issue Type +	Ma	Location *	WS
Category	Earthen Levee			GPS Latitude/Longitude	
				Start	End
Item	Vegetation			38.202997 °	38.197778 °
				-121.613450 °	-121.616080 °
DWR ID	DWR_RD0501_01_s_2012_974				
Comment Code					
V2 : Remove the wild growth other than native grasses from the levee slopes.					
Inspector Comment					
Remove the wild growth from the waterside slope.

RD 501 Levee mile 3.73-4.12 wild tree growth and vegetation blocking view of the levee slope.

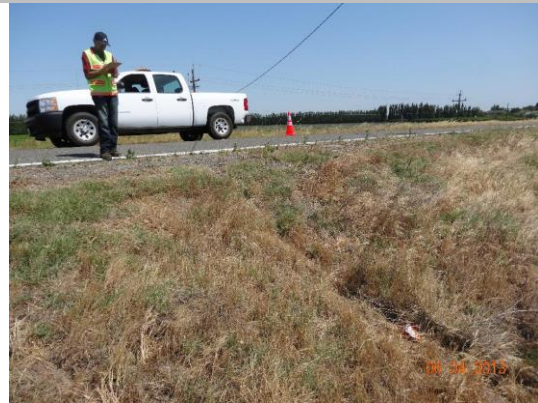
Photo 1 of 3 : UCIP\_SP\_2017\_19644\_33328.jpg

Comment Code					
Inspector Comment					
FS_ID:19644 DS_ID:21016 EP_NO: N/A Repair Type: Non-Urgent Crossing Status: Found UCIP Comments: Pipe section was altered/modified through levee crown. 12-inch pipe sleeved through existing pipe. Dense vegetation limits the inspector's visibility to identify signs of pipe failure (leaks) through the slope. Additional Notes: electrical conduit is disconnected on landside. Recommend removing vegetation along pipe alignment to conduct proper inspection of structure and appurtenances. Also need to contact owner to obtain maintenance records for crossing--need permit authorizing modifications. FIELD_STRUCT_DESC: 14-inch pipe through the levee, 3.2 feet below the crown. 12-inch pipe sleeved through existing 14-inch pipe and annular space grouted. 1.5-inch electrical conduit runs parrallel along 14-inch pipe. Pump on pile structure in channel. Walkway to pump. (USACE-1959). This entry matches the Drainage or Irrigation Structure referenced in O&M manual (HLM 4.30). FS Date: 6/4/2013

View of waterward side.

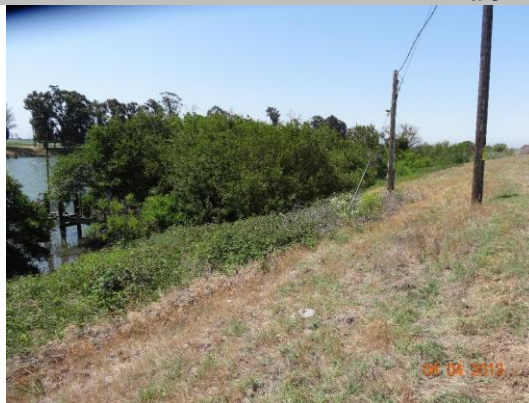
Photo 2 of 3 : UCIP\_SP\_2017\_19644\_33331.jpg

Overview of waterward side--pump station, platform, &amp; power pole.

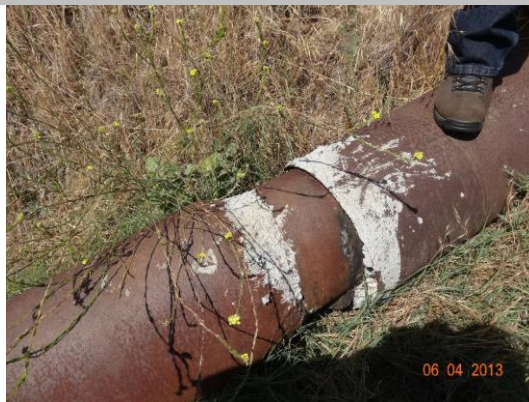
Photo 3 of 3 : UCIP\_SP\_2017\_19644\_33326.jpg

12-inch pipe sleeved through existing 14-inch pipe, and annular space grouted--waterward side.

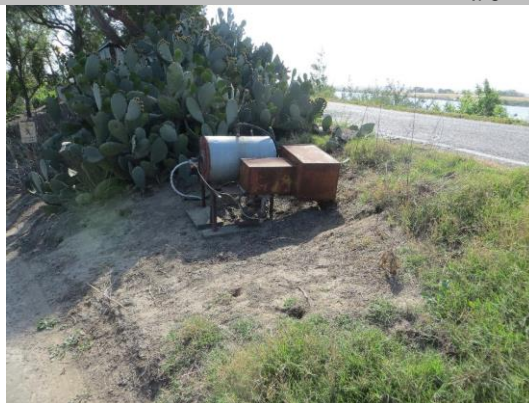
Photo 1 of 3 : UCIP\_SP\_2017\_44726\_73922.jpg

Siphon pump on LS shoulder. No connection at this time.

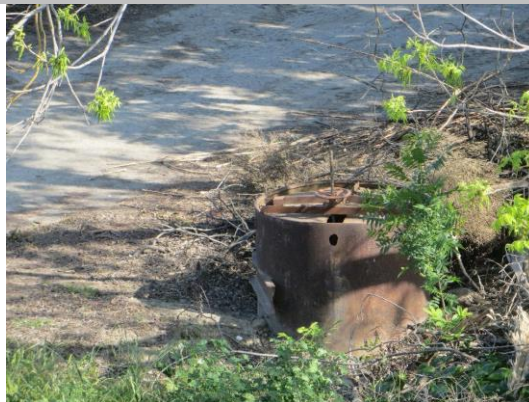
Photo 2 of 3 : UCIP\_SP\_2017\_44726\_73921.jpg

Steel standpipe and gatevalve on LS toe.

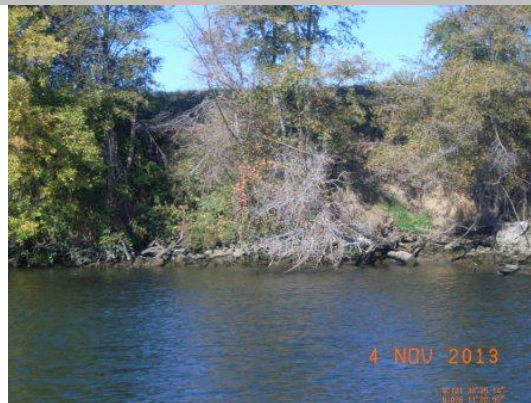
Photo 1 of 1 : SP\_2017\_RD0501\_169\_1\_20170404\_00001.jpg

LM Start	5.77	Rating **	M	Issue No.	1
LM End	5.84	Issue Type +	Ma	Location *	WS
Category	Supplemental			GPS Latitude/Longitude	
				Start	End
Item	2015 USACE Erosion Survey, DRAFT			38.190001 °	38.189311 °
				-121.643160 °	-121.643917 °
DWR ID	DWR_RD0501_01_f_2016_1				
Comment Code					
Inspector Comment					
2008 - Overstepped levee section with multiple small pockets of erosion 10 - 20 ft wide. 2013 - Site has fresh erosion and taller vertical sections. 2015: No observed changes. [2015 Site ID: STM_15-7_R]

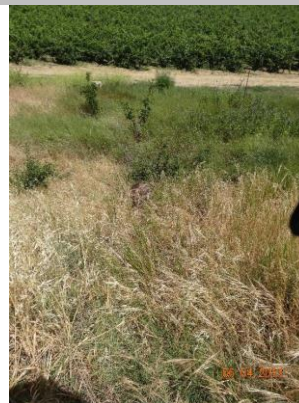
Photo 1 of 3 : UCIP\_SP\_2017\_32530\_58957.jpg

Comment Code					
Inspector Comment					
FS_ID:32530					
DS_ID:21020					
EP_NO: N/A					
Repair Type: Non-Urgent					
Crossing Status: Found					
UCIP Comments: Dense vegetation limits the inspector's visibility to identify signs of pipe failure (leaks) through the slope. Recommend removing vegetation along pipe alignment to conduct proper inspection of structure and appurtenances. If structure is no longer used--Need to contact owner to determine status. If crossing is no longer used owner will need to coordinate with CVFPB.					
FIELD_STRUCT_DESC: Abandoned 16-inch pipe through the levee, 6.5 feet below the crown. Siphon breaker and service pole on landward shoulder. Electrical box on landside toe. Pump on pile stucture in channel.					
FS Date: 6/4/2013

Abandoned 16-inch pipe on landward side.

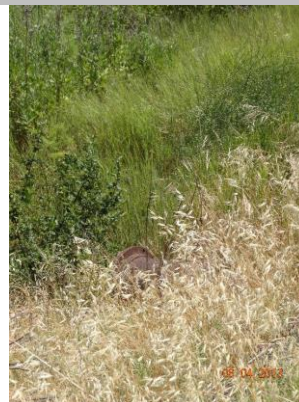
Photo 2 of 3 : UCIP\_SP\_2017\_32530\_58956.jpg

Overview of waterward side--section of pipe visible through dense vegetation.

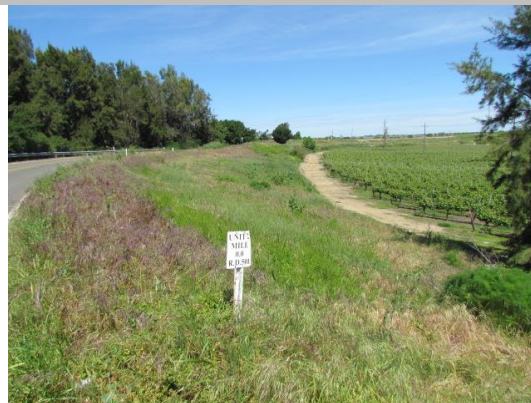
Photo 1 of 1 : SP\_2017\_RD0501\_170\_20\_20170522\_00042.jpg

LM Start	0.01	Rating **	U	Issue No.	20
LM End	1.09	Issue Type +	Ma	Location *	LS
Category	Earthen Levee			GPS Latitude/Longitude	
				Start	End
Item	Vegetation			38.184052 °	38.198920 °
				-121.657855 °	-121.655567 °
DWR ID	DWR_RD0501_02_s _ 2017_20				
Comment Code					
V1 : Control annual grass and weeds on the levee slopes and easements.					
Inspector Comment					
Control the annual grasses and weeds from the landside slope.

RD 501 Unit 2 levee mile 0.01-1.09 landside levee slope.

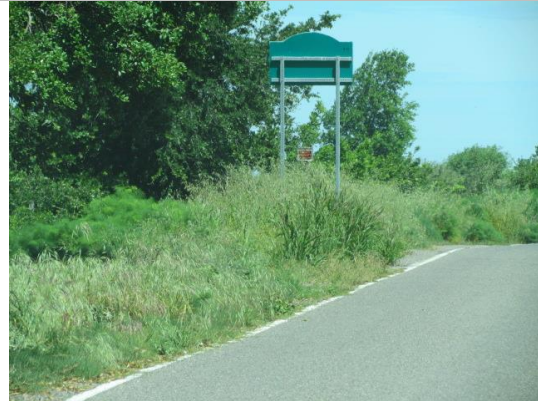
Photo 1 of 1 : SP\_2017\_RD0501\_170\_22\_20170522\_00043.jpg

LM Start	0.10	Rating **	U	Issue No.	22
LM End	3.55	Issue Type +	Ma	Location *	WS
Category	Earthen Levee			GPS Latitude/Longitude	
				Start	End
Item	Vegetation			38.185232 °	38.227825 °
				-121.658677 °	-121.673105 °
DWR ID	DWR_RD0501_02_s_2017_22				
Comment Code					
V1 : Control annual grass and weeds on the levee slopes and easements.					
Inspector Comment					
Control the annual grasses and weeds on the slope and shoulder.

RD 501 Unit 2 levee mile 0.10-3.55 wateside shoulder and slope.

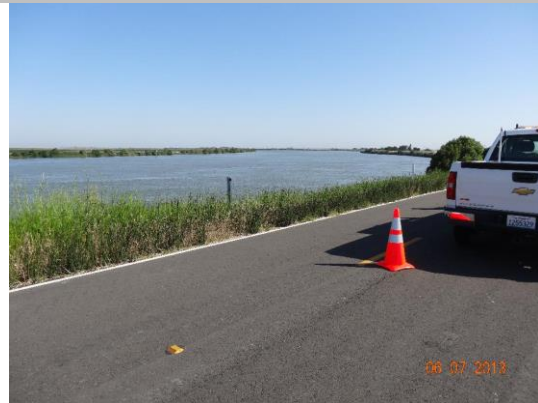
Photo 1 of 3 : UCIP\_SP\_2017\_32531\_58960.jpg

View of crown.

Comment Code						
Inspector Comment						
FS_ID:32531 DS_ID:21035 EP_NO: N/A Repair Type: Non-Urgent Crossing Status: Found UCIP Comments: Dense vegetation limits the inspector's visibility to identify signs of pipe failure (leaks) through the slope. Recommend removing vegetation along pipe alignment to conduct proper inspection of structure and appurtenances. Need to determine owner and status of crossing. FIELD_STRUCT_DESC: 10-inch pipe sleeved through a 12-inch pipe through the levee, 5.0 feet below the crown. Pump on waterward side. (USACE-1959). This entry matches the Drainage or Irrigation Structure referenced in O&M manual (HLM 0.60). FS Date: 6/7/2013

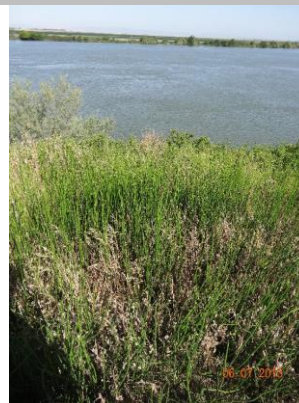
Photo 2 of 3 : UCIP\_SP\_2017\_32531\_58958.jpg

Overview of waterward side. Inaccessible due to dense vegetation.

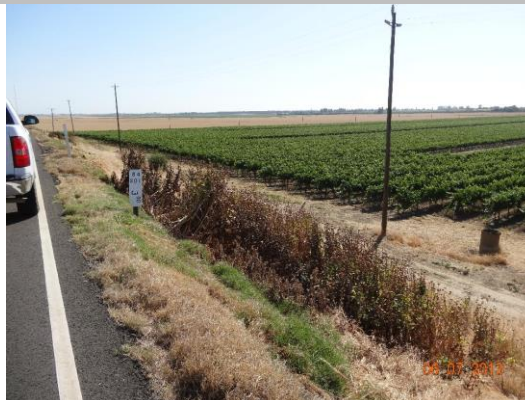
Photo 3 of 3 : UCIP\_SP\_2017\_32531\_58959.jpg

Overview of landward side.

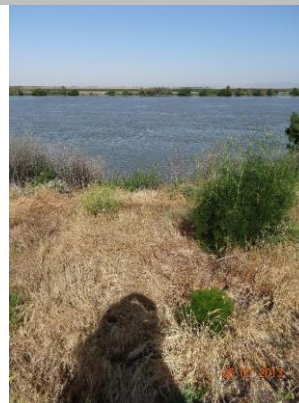
Photo 1 of 3 : UCIP\_SP\_2017\_50018\_58967.jpg

Comment Code					
Inspector Comment					
FS_ID:50018 DS_ID:21092 EP_NO: 3703 Repair Type: Urgent Crossing Status: Found UCIP Comments: 8/22/2016 Same as last inspection -- pipe is deteriorating and breaking apart (visible on WS). (DWR UCIP - omagana)6/07/2013 Deteriorated pipe with holes present at intake. Dense vegetation limits the inspector's visibility to identify signs of pipe failure (leaks) through the slope. Recommend removing vegetation along pipe alignment to conduct proper inspection of structure and appurtenances. If crossing is no longer used --owner will need coordinate with CVFPB to address crossing. Need to coordinate with DWR Inspector and CVFPB. (DWR UCIP - omagana) FIELD_STRUCT_DESC: *ABANDONED* 8-inch steel pipe through the levee, 1.7 feet below the crown. Siphon breaker on apex of pipe located on the landside (LS) shoulder. Pipe discharges into concrete sump near LS toe. Pipe is exposed along LS slope. Second 8-inch pipe is approximately 1 foot apart which is visible on LS. Pipe is also visible on waterside (WS). (Permit No. 3703, 1961 - Enzo Guidi) [Additional Reference(s): DWR Levee Log, 2005]. FS Date: 8/22/2016

Overview of WS--20 foot berm present.

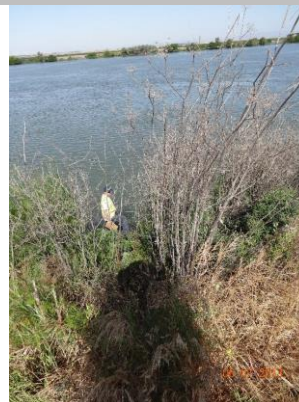
Photo 2 of 3 : UCIP\_SP\_2017\_50018\_58965.jpg

View of WS. Inspector is standing near exposed section of pipe at levee toe.

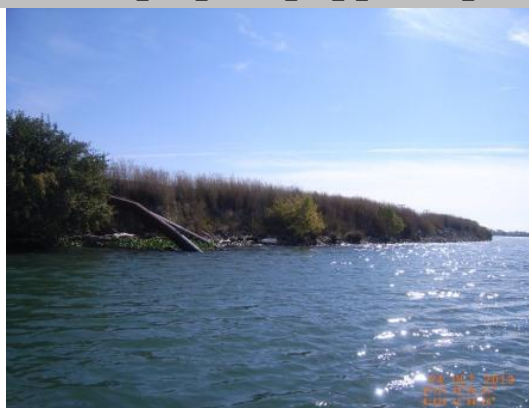
Photo 1 of 1 : SP\_2017\_RD0501\_170\_1\_20170404\_00001.jpg

LM Start	1.10	Rating **	M	Issue No.	1
LM End	1.17	Issue Type +	Ma	Location *	WS
Category	Supplemental			GPS Latitude/Longitude	
				Start	End
Item	2015 USACE Erosion Survey, DRAFT			38.199128 °	38.200146 °
				-121.655881 °	-121.655638 °
DWR ID	DWR_RD0501_02_f_2016_1				
Comment Code					
Inspector Comment					
2005 - Large vertical sections due to wave wash. New stone dumped on the bank with exposed geotextile. Cohesive toe has thin weak stratigraphic unit that is washing out. 2006 - Partially repaired, but 100 ft in the middle of the reach has exposed filter fabric and stone riprap is gone. 2010 - Site extended downstream to include new erosion pocket. 2015: No observed changes. [2015 Site ID: CHS_15-9_L]

USACE 2013 Photo #1

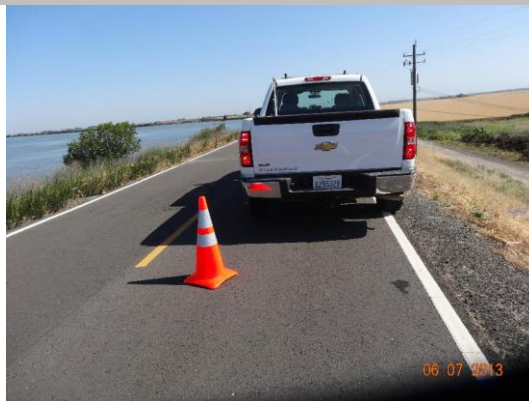
Photo 1 of 3 : UCIP\_SP\_2017\_44865\_58975.jpg

Comment Code						
Inspector Comment						
FS_ID:44865 DS_ID:21038 EP_NO: 2817 Repair Type: Non-Urgent Crossing Status: Found UCIP Comments: Dense vegetation limits the inspector's visibility to identify signs of pipe failure (leaks) through the slope. Recommend removing vegetation along pipe alignment to conduct proper inspection of structure and appurtenances. Scour hole located on waterward side. FIELD_STRUCT_DESC: 20-inch steel drainpipe sleeved through a 24-inch steel pipe through the levee, 9.0 feet below the crown. Flap gate on waterward end. Two cutoff collars around the pipe at both shoulders. Pipe exposed along both slopes. Rock revetment on waterward slope. Berm on waterward side is over 20 feet. (Permit No. 2817-1959) FS Date: 6/7/2013

View of levee crown at crossings.

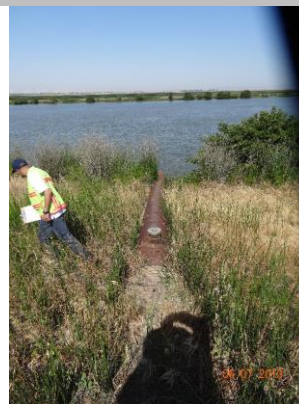
Photo 2 of 3 : UCIP\_SP\_2017\_44865\_58972.jpg

View of waterward side--pipe section exposed and siphon breaker. Over 20 feet berm on waterward side.

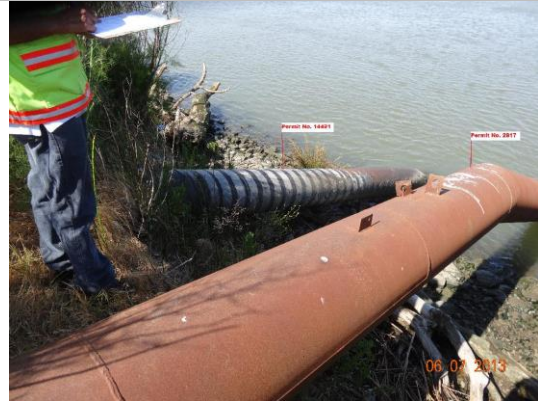
Photo 3 of 3 : UCIP\_SP\_2017\_44865\_58974.jpg

Comment Code						
Inspector Comment						
FS_ID:44865 DS_ID:21038 EP_NO: 2817 Repair Type: Non-Urgent Crossing Status: Found UCIP Comments: Dense vegetation limits the inspector's visibility to identify signs of pipe failure (leaks) through the slope. Recommend removing vegetation along pipe alignment to conduct proper inspection of structure and appurtenances. Scour hole located on waterward side. FIELD_STRUCT_DESC: 20-inch steel drainpipe sleeved through a 24-inch steel pipe through the levee, 9.0 feet below the crown. Flap gate on waterward end. Two cutoff collars around the pipe at both shoulders. Pipe exposed along both slopes. Rock revetment on waterward slope. Berm on waterward side is over 20 feet. (Permit No. 2817-1959) FS Date: 6/7/2013

Waterward side--2-24 inch pipe inlets.

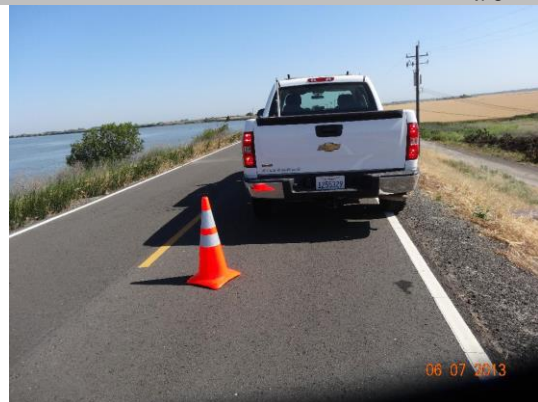
Photo 1 of 3 : UCIP\_SP\_2017\_44866\_58981.jpg

Comment Code					
Inspector Comment					
FS_ID:44866					
DS_ID:21094					
EP_NO: 14491					
Repair Type: Non-Urgent					
Crossing Status: Found					
UCIP Comments: Dense vegetation limits the inspector's visibility to identify signs of pipe failure (leaks) through the slope. Recommend removing vegetation along pipe alignment to conduct proper inspection of structure and appurtenances. Scour hole present on waterward side.					
FIELD_STRUCT_DESC: 24-inch steel drainpipe through the levee, 4.5 feet below the crown. Cutoff wall around pipe at center of levee. Siphon breaker on apex of pipe at waterward shoulder. Pump on landward side. (Permit No. 14491-1986)					
FS Date: 6/7/2013

View of downstream crown.

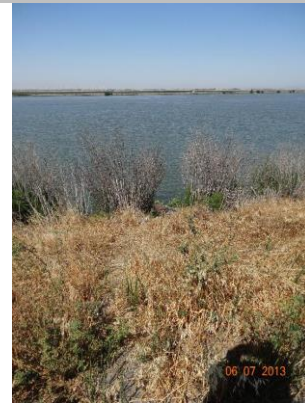
Photo 1 of 3 : UCIP\_SP\_2017\_44867\_58987.jpg

Comment Code					
Inspector Comment					
FS_ID:44867 DS_ID:21093 EP_NO: 13520 Repair Type: Non-Urgent Crossing Status: Found UCIP Comments: Dense vegetation limits the inspector's visibility to identify signs of pipe failure (leaks) through the slope. Recommend removing vegetation along pipe alignment to conduct proper inspection of structure and appurtenances. Owner needs to be informed about the vegetation clearance required for proper inspection. FIELD_STRUCT_DESC: 18-inch steel pipe through the levee, 3.4 feet below the crown. Steel cutoff wall around pipe at center of levee. Siphon breaker on apex of pipe on landward shoulder. Pipe extends from sump off of landward toe. Pipe exposed along waterward slope. Rock revetment on waterward slope. (Permit No. 13520-1982) FS Date: 6/7/2013

Overview of waterside. Dense vegetation.

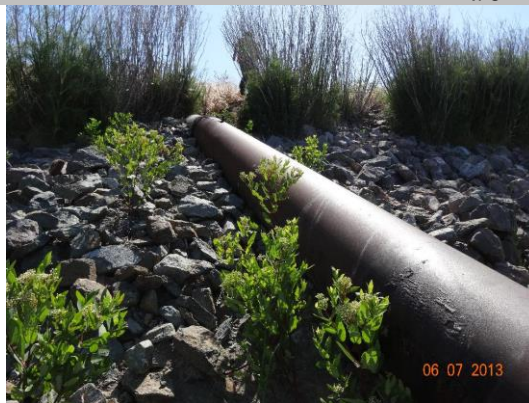
Photo 2 of 3 : UCIP\_SP\_2017\_44867\_58982.jpg

Comment Code						
Inspector Comment						
FS_ID:44867 DS_ID:21093 EP_NO: 13520 Repair Type: Non-Urgent Crossing Status: Found UCIP Comments: Dense vegetation limits the inspector's visibility to identify signs of pipe failure (leaks) through the slope. Recommend removing vegetation along pipe alignment to conduct proper inspection of structure and appurtenances. Owner needs to be informed about the vegetation clearance required for proper inspection. FIELD_STRUCT_DESC: 18-inch steel pipe through the levee, 3.4 feet below the crown. Steel cutoff wall around pipe at center of levee. Siphon breaker on apex of pipe on landward shoulder. Pipe extends from sump off of landward toe. Pipe exposed along waterward slope. Rock revetment on waterward slope. (Permit No. 13520-1982) FS Date: 6/7/2013

View of waterward side--pipe extends from berm to river.

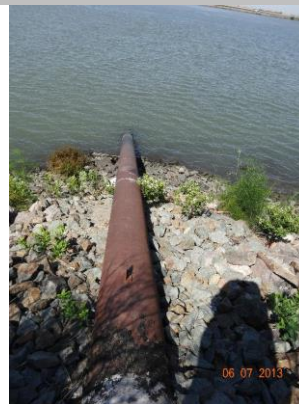
Photo 3 of 3 : UCIP\_SP\_2017\_44867\_58985.jpg

Photo of pipe looking from berm edge to river edge.

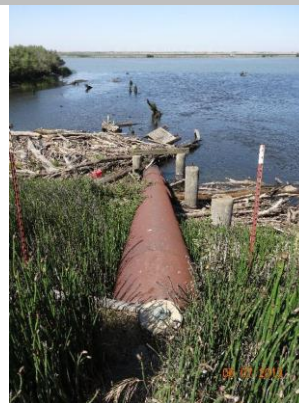
Photo 3 of 3 : UCIP\_SP\_2017\_40489\_33357.jpg

Comment Code					
Inspector Comment					
FS_ID:40489 DS_ID:21042 EP_NO: 15477 Repair Type: Non-Urgent Crossing Status: Found UCIP Comments: Stacey Boyd, LMA superintendent for RD0501, confirmed the removal and replacement of existing crossing under new permit no. 18811. New crossing will be a 30-inch diameter discharge pipe above the design flood plane. Construction will start soon. Update record once the project is completed. Dense vegetation on both waterside and landside. Recommend removing vegetation along pipe alignment to conduct proper inspection of structure and appurtenances. FIELD_STRUCT_DESC: 42-inch steel pipe through the levee, 6.5 feet below the crown. Siphon breaker on waterward slope. Pump on the landward side (Permit No. 15477, 1990). Pipe exposed along both slopes. (USACE-1959). This entry matches the Drainage or Irrigation Structure referenced in O&M manual (HLM 2.0). FS Date: 6/7/2013

Siphon breaker on apex of steel pipe waterside.

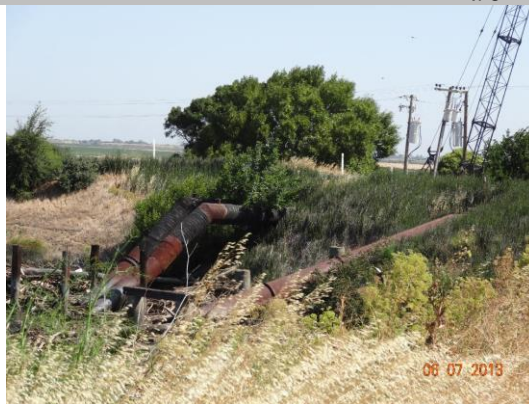
Photo 2 of 3 : UCIP\_SP\_2017\_47049\_33373.jpg

Overview of dual pipes on waterward side.

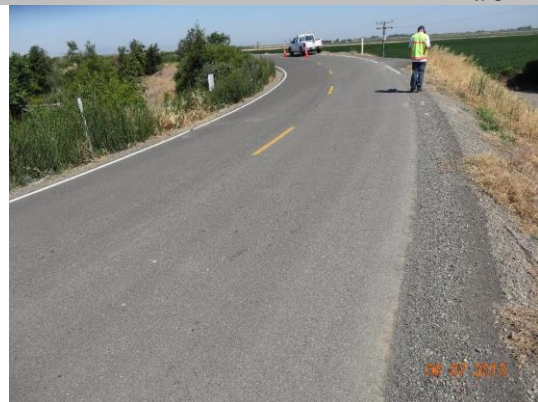
Photo 1 of 3 : UCIP\_SP\_2017\_47050\_33371.jpg

Comment Code					
Inspector Comment					
FS_ID:47050 DS_ID:21084 EP_NO: N/A Repair Type: Non-Urgent Crossing Status: Found UCIP Comments: Dense vegetation limits the inspector's visibility to identify signs of pipe failure (leaks) through the slope. Recommend removing vegetation along pipe alignment to conduct proper inspection of structure and appurtenances. FIELD_STRUCT_DESC: 2 of 2: 36-inch steel pipe through the levee, 7.0 feet below the crown. Siphon breaker on waterward shoulder. Pumps on landward side. Pipe exposed along both slopes. Pipe supports at levee shoulders, were cutoff walls from pre-existing pipe. (Permit No. 15477-1990) Pipes are approximately 36 inches apart. FS Date: 6/7/2013

Overview of levee crown at crossing.

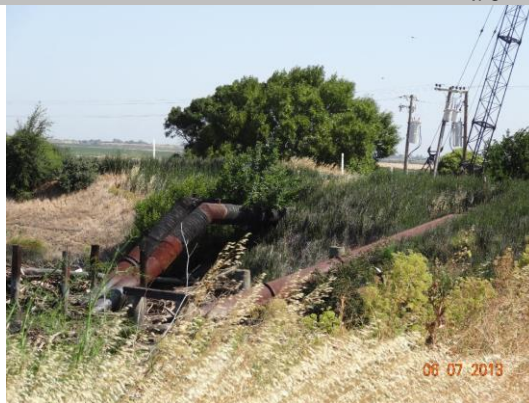
Photo 2 of 3 : UCIP\_SP\_2017\_47050\_33372.jpg

Comment Code						
Inspector Comment						
FS_ID:47050 DS_ID:21084 EP_NO: N/A Repair Type: Non-Urgent Crossing Status: Found UCIP Comments: Dense vegetation limits the inspector's visibility to identify signs of pipe failure (leaks) through the slope. Recommend removing vegetation along pipe alignment to conduct proper inspection of structure and appurtenances. FIELD_STRUCT_DESC: 2 of 2: 36-inch steel pipe through the levee, 7.0 feet below the crown. Siphon breaker on waterward shoulder. Pumps on landward side. Pipe exposed along both slopes. Pipe supports at levee shoulders, were cutoff walls from pre-existing pipe. (Permit No. 15477-1990) Pipes are approximately 36 inches apart. FS Date: 6/7/2013

Overview of waterward side--3 crossings visible 1-42 inch pipe and 2-36 inch pipes.

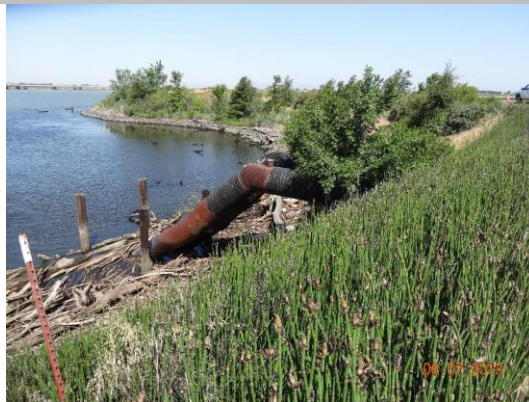
Photo 3 of 3 : UCIP\_SP\_2017\_47050\_33368.jpg

View of 36 inch pipes exposed on waterward side.

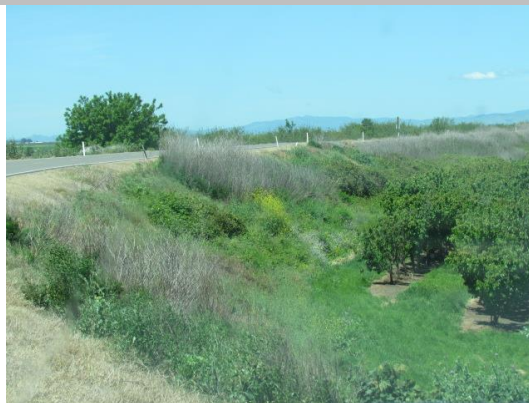
Photo 1 of 1 : SP\_2017\_RD0501\_170\_24\_20170522\_00041.jpg

LM Start	1.88	Rating **	U	Issue No.	24
LM End	3.55	Issue Type +	Ma	Location *	LS
Category	Earthen Levee			GPS Latitude/Longitude	
				Start	End
Item	Vegetation			38.209257 °	38.227825 °
				-121.656630 °	-121.673105 °
DWR ID	DWR_RD0501_02_s_2017_24				
Comment Code					
V1 : Control annual grass and weeds on the levee slopes and easements.					
Inspector Comment					
Control the annual grasses and weeds on the landside slope.

RD 501 Unit 2 levee mile 1.88-3.55 landside slope.

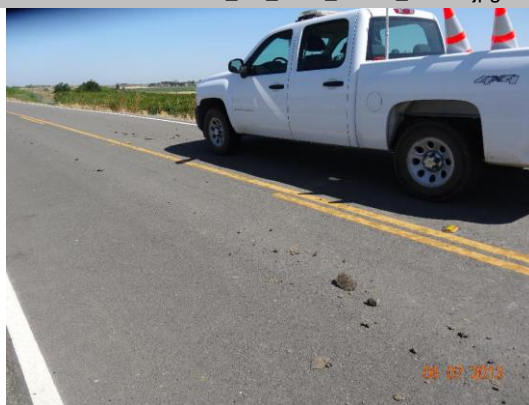
Photo 1 of 3 : UCIP\_SP\_2017\_32537\_58989.jpg

Comment Code					
Inspector Comment					
FS_ID:32537 DS_ID:21044 EP_NO: N/A Repair Type: Non-Urgent Crossing Status: Found UCIP Comments: Dense vegetation limits the inspector's visibility to identify signs of pipe failure (leaks) through the slope. Recommend removing vegetation along pipe alignment to conduct proper inspection of structure and appurtenances. FIELD_STRUCT_DESC: 14-inch steel pipe through the levee, 6.2 feet below the crown. Siphon breaker on waterward shoulder. (USACE-1959). This entry matches the Drainage or Irrigation Structure referenced in O&M manual (HLM 2.60). Pipe was repaired in 1984 under Permit No. 13937. The repair consisted of replacing the pipeline within the levee crown with new soil proofed steel pipe. FS Date: 6/7/2013

View of levee crown--narrow road.

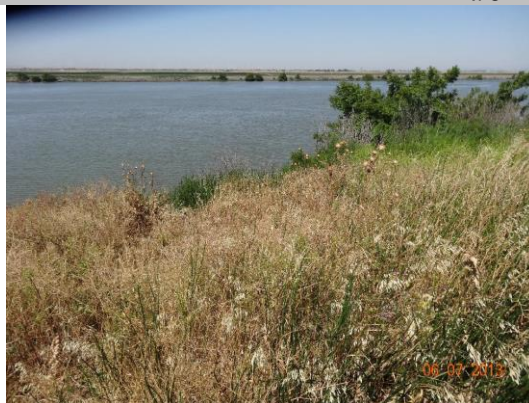
Photo 2 of 3 : UCIP\_SP\_2017\_32537\_58990.jpg

Comment Code						
Inspector Comment						
FS_ID:32537 DS_ID:21044 EP_NO: N/A Repair Type: Non-Urgent Crossing Status: Found UCIP Comments: Dense vegetation limits the inspector's visibility to identify signs of pipe failure (leaks) through the slope. Recommend removing vegetation along pipe alignment to conduct proper inspection of structure and appurtenances. FIELD_STRUCT_DESC: 14-inch steel pipe through the levee, 6.2 feet below the crown. Siphon breaker on waterward shoulder. (USACE-1959). This entry matches the Drainage or Irrigation Structure referenced in O&M manual (HLM 2.60). Pipe was repaired in 1984 under Permit No. 13937. The repair consisted of replacing the pipeline within the levee crown with new soil proofed steel pipe. FS Date: 6/7/2013

Photo taken just downstream of crossing looking at waterward side.

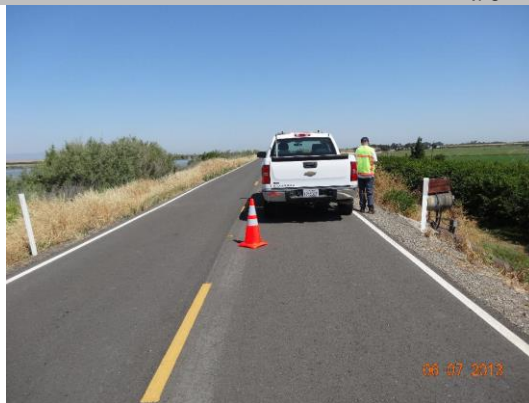
Photo 1 of 3 : UCIP\_SP\_2017\_44872\_33392.jpg

Comment Code					
Inspector Comment					
FS_ID:44872 DS_ID:21045 EP_NO: 4733 Repair Type: Non-Urgent Crossing Status: Found UCIP Comments: Dense vegetation limits the inspector's visibility to identify signs of pipe failure (leaks) through the waterward slope. Recommend removing vegetation along pipe alignment to conduct proper inspection of structure and appurtenances. FIELD_STRUCT_DESC: 18-inch pipe through the levee, 4.0 feet below the crown. Cutoff wall around pipe at center of levee. Siphon breaker on apex of pipe at landward shoulder. Rock revetment on waterward slope. 16-inch pipe welded to 18-inch pipe near landward shoulder, extends down landward slope. Pipe exposed along both slopes. (Permit No. 4733-1964) FS Date: 6/7/2013

View of levee crown at crossing.

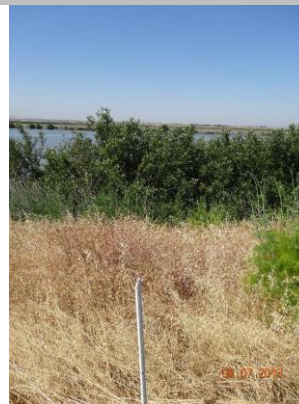
Photo 2 of 3 : UCIP\_SP\_2017\_44872\_33393.jpg

Dense vegetation hindered inspection on waterward side.

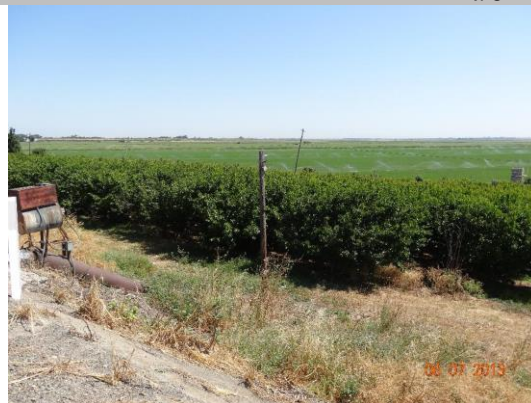
Photo 3 of 3 : UCIP\_SP\_2017\_44872\_33391.jpg

Comment Code						
Inspector Comment						
FS_ID:44872						
DS_ID:21045						
EP_NO: 4733						
Repair Type: Non-Urgent						
Crossing Status: Found						
UCIP Comments: Dense vegetation limits the inspector's visibility to identify signs of pipe failure (leaks) through the waterward slope. Recommend removing vegetation along pipe alignment to conduct proper inspection of structure and appurtenances.						
FIELD_STRUCT_DESC: 18-inch pipe through the levee, 4.0 feet below the crown. Cutoff wall around pipe at center of levee. Siphon breaker on apex of pipe at landward shoulder. Rock revetment on waterward slope. 16-inch pipe welded to 18-inch pipe near landward shoulder, extends down landward slope. Pipe exposed along both slopes. (Permit No. 4733-1964)						
FS Date: 6/7/2013

Overview of landward side. Pump system located near crown hinge point.

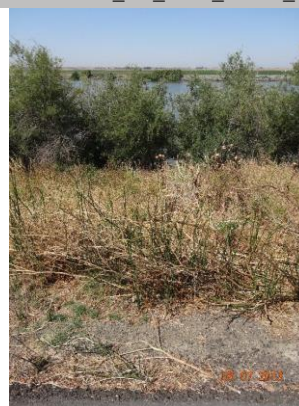
Photo 1 of 3 : UCIP\_SP\_2017\_19657\_33396.jpg

Comment Code					
Inspector Comment					
FS_ID:19657					
DS_ID:21046					
EP_NO: N/A					
Repair Type: Non-Urgent					
Crossing Status: Found					
UCIP Comments: Dense vegetation limits the inspector's visibility to identify signs of pipe failure (leaks) through the waterward slope. Recommend removing vegetation along pipe alignment to conduct proper inspection of structure and appurtenances.					
FIELD_STRUCT_DESC: 16-inch pipe sleeved through a 20-inch pipe through the levee, 4.7 feet below the crown. Annular gap grouted. Siphon breaker on landward shoulder. Pipe exposed along both slopes. (USACE-1959). This entry matches the Drainage or Irrigation Structure referenced in O&M manual (HLM 3.30). The 16-inch pipe was sleeved through pre-existing pipe under Permit No. 2645 (1959).					
FS Date: 8/22/2013

Dense vegetation along the crown hinge point and beginning section of waterward slope.

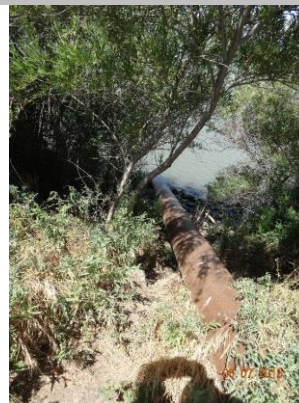
Photo 3 of 3 : UCIP\_SP\_2017\_19657\_33397.jpg

Comment Code						
Inspector Comment						
FS_ID:19657						
DS_ID:21046						
EP_NO: N/A						
Repair Type: Non-Urgent						
Crossing Status: Found						
UCIP Comments: Dense vegetation limits the inspector's visibility to identify signs of pipe failure (leaks) through the waterward slope. Recommend removing vegetation along pipe alignment to conduct proper inspection of structure and appurtenances.						
FIELD_STRUCT_DESC: 16-inch pipe sleeved through a 20-inch pipe through the levee, 4.7 feet below the crown. Annular gap grouted. Siphon breaker on landward shoulder. Pipe exposed along both slopes. (USACE-1959). This entry matches the Drainage or Irrigation Structure referenced in O&M manual (HLM 3.30). The 16-inch pipe was sleeved through pre-existing pipe under Permit No. 2645 (1959).						
FS Date: 8/22/2013

Overview of pipe along waterward side.

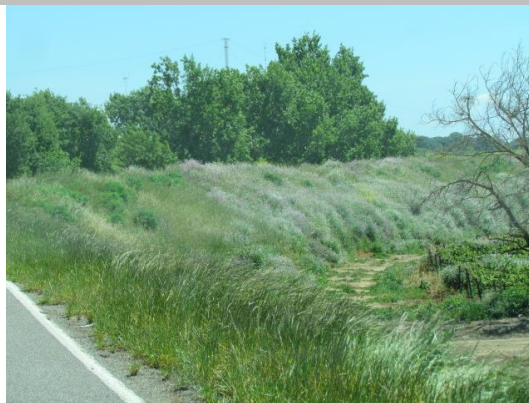
Photo 1 of 1 : SP\_2017\_RD0501\_171\_28\_20170522\_00070.jpg

LM Start	0.00	Rating **	U	Issue No.	28
LM End	6.55	Issue Type +	Ma	Location *	LS
Category	Earthen Levee			GPS Latitude/Longitude	
				Start	End
Item	Vegetation			38.228053 °	38.290017 °
				-121.673038 °	-121.624857 °
DWR ID	DWR_RD0501_03_s_2017_28				
Comment Code					
V1 : Control annual grass and weeds on the levee slopes and easements.					
Inspector Comment					
Control annual grasses and weeds on the levee slope and toe.

RD 501 Unit 3 landside shoulder and slope downstream from levee mile 0.00.

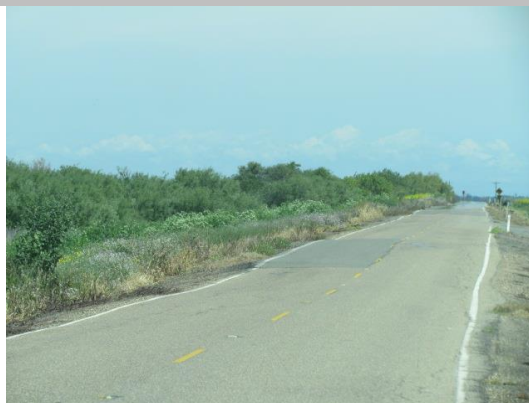
Photo 1 of 1 : SP\_2017\_RD0501\_171\_29\_20170522\_00069.jpg

LM Start	0.51	Rating **	U	Issue No.	29
LM End	7.71	Issue Type +	Ma	Location *	WS
Category	Earthen Levee			GPS Latitude/Longitude	
				Start	End
Item	Vegetation			38.233439 °	38.285455 °
				-121.666765 °	-121.606027 °
DWR ID	DWR_RD0501_03_s_2017_29				
Comment Code					
V1 : Control annual grass and weeds on the levee slopes and easements.					
Inspector Comment					
Looking downstream from the waterside slope levee mile 0.51 to 7.71 the weeds and annual grasses should be controlled from the waterside slope and toe.

RD 501 Unit 3 From levee mile 0.00-7.71 waterside slope.

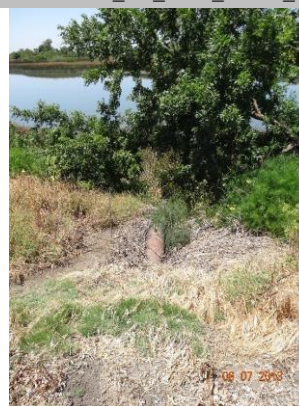
Photo 1 of 3 : UCIP\_SP\_2017\_44873\_33405.jpg

Comment Code					
Inspector Comment					
FS_ID:44873 DS_ID:21065 EP_NO: N/A Repair Type: Non-Urgent Crossing Status: Found UCIP Comments: Pump operating during inspection. Need to determine owner. Dense vegetation limits the inspector's visibility to identify signs of pipe failure (leaks) through the waterward slope. Recommend removing vegetation along pipe alignment to conduct proper inspection of structure and appurtenances. FIELD_STRUCT_DESC: 14-inch steel pipe through the levee, 6.3 feet below the crown instead of 16-inch pipe mentioned in O&M. Siphon breaker on landward slope. Pipe exposed on both slopes. (USACE-1959). This entry matches the Drainage or Irrigation Structure referenced in O&M manual (HLM 0.70). FS Date: 6/7/2013

Overview of waterward side. Dense vegetation limits proper inspection.

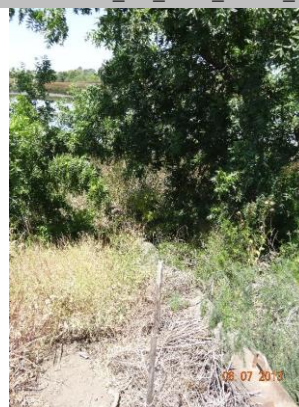
Photo 2 of 3 : UCIP\_SP\_2017\_44873\_33402.jpg

Conditions of waterward slope--dense vegetation along slope.

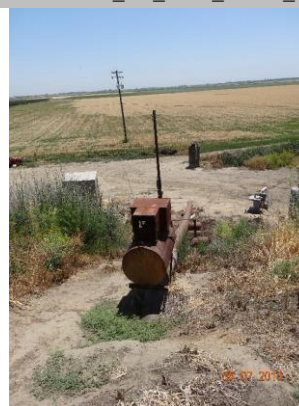
Photo 3 of 3 : UCIP\_SP\_2017\_44873\_33404.jpg

Item	DWR UCIP Field Study			38.234679 °		38.234679 °
				-121.665417 °		-121.665417 °
DWR ID						
Comment Code						
Inspector Comment						
FS_ID:44873						
DS_ID:21065						
EP_NO: N/A						
Repair Type: Non-Urgent						
Crossing Status: Found						
UCIP Comments: Pump operating during inspection. Need to determine owner. Dense vegetation limits the inspector's visibility to identify signs of pipe failure (leaks) through the waterward slope. Recommend removing vegetation along pipe alignment to conduct proper inspection of structure and appurtenances.						
FIELD_STRUCT_DESC: 14-inch steel pipe through the levee, 6.3 feet below the crown instead of 16-inch pipe mentioned in O&M. Siphon breaker on landward slope. Pipe exposed on both slopes. (USACE-1959). This entry matches the Drainage or Irrigation Structure referenced in O&M manual (HLM 0.70).						
FS Date: 6/7/2013

Overview of landward side--pump sytem, pipe, and standpipe.

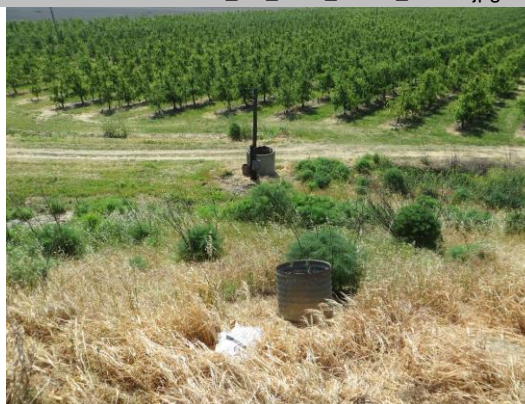
Photo 1 of 2 : UCIP\_SP\_2017\_44728\_73924.jpg

Comment Code					
Inspector Comment					
FS_ID:44728					
DS_ID:21066					
EP_NO: N/A					
Repair Type: Non-Urgent					
Crossing Status: Found					
UCIP Comments: Pipe appears abandoned and if so should be done so properly. Wooden walkway to pier in disrepair and a hazard.					
FIELD_STRUCT_DESC: 12-inch steel irrigation pipe through the levee, 8.0-feet below the crown. Siphon breaker on landward slope. Pump on pipe structure in stream. Concrete standpipe and distribution slide gates at landward toe. (USACE-1959). This entry matches the Drainage or Irrigation Structure referenced in O&M manual (HLM 1.50). 1.5-inch electrical conduit at same location.					
FS Date: 6/7/2013

Siphon breaker in 24-inch CMP riser on LS slope. Standpipe visible at LS toe.

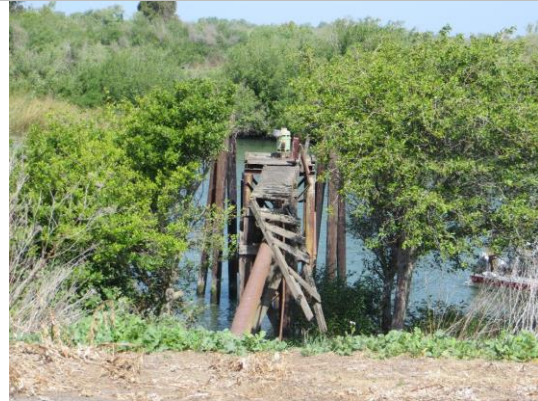
Photo 2 of 2 : UCIP\_SP\_2017\_44728\_73923.jpg

LM Start	1.35	Rating **	M	Issue No.	132 (cont)
LM End	1.35	Issue Type +	En	Location *	WS
Category	Supplemental			GPS Latitude/Longitude	
				Start	End
Item	DWR UCIP Field Study			38.242879 °	38.242879 °
				-121.659450 °	-121.659450 °
DWR ID					
Comment Code					
Inspector Comment					
FS_ID:44728 DS_ID:21066 EP_NO: N/A Repair Type: Non-Urgent Crossing Status: Found UCIP Comments: Pipe appears abandoned and if so should be done so properly. Wooden walkway to pier in disrepair and a hazard. FIELD_STRUCT_DESC: 12-inch steel irrigation pipe through the levee, 8.0-feet below the crown. Siphon breaker on landward slope. Pump on pipe structure in stream. Concrete standpipe and distribution slide gates at landward toe. (USACE-1959). This entry matches the Drainage or Irrigation Structure referenced in O&M manual (HLM 1.50). 1.5-inch electrical conduit at same location. FS Date: 6/7/2013

Pump on wooden pier off WS toe.

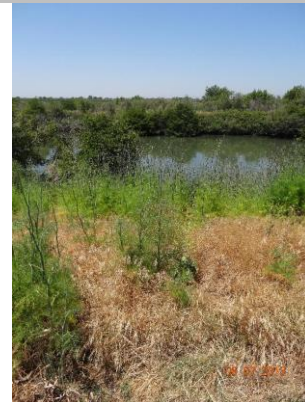
Photo 1 of 2 : UCIP\_SP\_2017\_43503\_33410.jpg

Comment Code					
Inspector Comment					
FS_ID:43503 DS_ID:21068 EP_NO: N/A Repair Type: Non-Urgent Crossing Status: Found UCIP Comments: Authorized or Unauthorized? Need permit authorizing work. Dense vegetation limits the inspector's visibility to identify signs of pipe failure (leaks) through the slope on both waterward and landward side. Recommend removing vegetation along pipe alignment to conduct proper inspection of structure and appurtenances. FIELD_STRUCT_DESC: 10-inch steel pipe through the levee, 6.3 feet below the crown. Pump, gate valve and switch box on waterward slope. Originally reported as 3.8-feet below crown in O+M manual, 1959 at HLM: 2.0. FS Date: 6/7/2013

Overview of waterward side. Pipe is completely obstructed by dense vegetation.

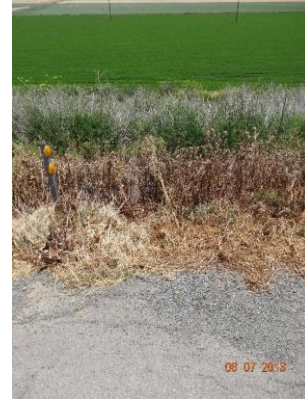
Photo 2 of 2 : UCIP\_SP\_2017\_43503\_33411.jpg

Item	DWR UCIP Field Study			38.249362 °		38.249362 °
				-121.656357 °		-121.656357 °
DWR ID						
Comment Code						
Inspector Comment						
FS_ID:43503 DS_ID:21068 EP_NO: N/A Repair Type: Non-Urgent Crossing Status: Found UCIP Comments: Authorized or Unauthorized? Need permit authorizing work. Dense vegetation limits the inspector's visibility to identify signs of pipe failure (leaks) through the slope on both waterward and landward side. Recommend removing vegetation along pipe alignment to conduct proper inspection of structure and appurtenances. FIELD_STRUCT_DESC: 10-inch steel pipe through the levee, 6.3 feet below the crown. Pump, gate valve and switch box on waterward slope. Originally reported as 3.8-feet below crown in O+M manual, 1959 at HLM: 2.0. FS Date: 6/7/2013

Overview of landward side. Pipe is visible however dense vegetation limits proper inspection.

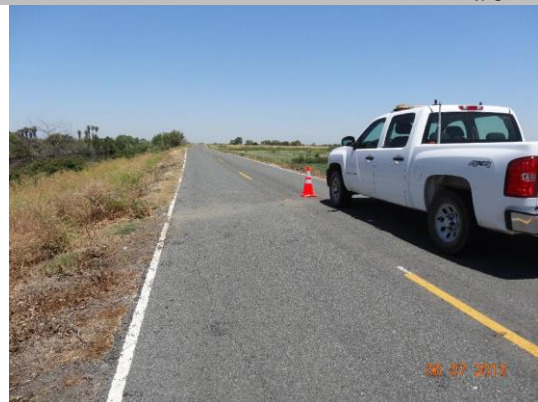
Photo 1 of 3 : UCIP\_SP\_2017\_18945\_31607.jpg

LM Start	2.52	Rating **	M	Issue No.	134
LM End	2.52	Issue Type +	En	Location *	WS
Category	Supplemental			GPS Latitude/Longitude	
				Start	End
Item	DWR UCIP Field Study			38.256255 °	38.256255 °
				-121.651551 °	-121.651551 °
DWR ID					
Comment Code					
Inspector Comment					
FS_ID:18945 DS_ID:21047 EP_NO: N/A Repair Type: Non-Urgent Crossing Status: Found UCIP Comments: Need to determine owner of structure. Recommend removing vegetation along pipe alignment to conduct proper inspection of structure and appurtenances. FIELD_STRUCT_DESC: 16-inch steel pipe through the levee, 3.3 feet below the crown. Gate valve and switch box on landward slope. Pipe exposed on both slopes. (USACE-1959) Riprap on waterward side. This entry matches the Drainage or Irrigation Structure referenced in O&M manual (HLM 2.70). FS Date: 6/7/2013

Overview of levee crown at crossing.

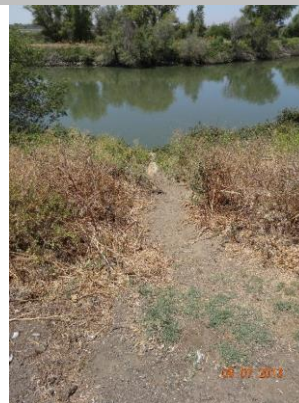
Photo 2 of 3 : UCIP\_SP\_2017\_18945\_31609.jpg

LM Start	2.52	Rating **	M	Issue No.	134 (cont)	
LM End	2.52	Issue Type +	En	Location *	WS	
Category	Supplemental			GPS Latitude/Longitude		
				Start		End
Item	DWR UCIP Field Study			38.256255 °		38.256255 °
				-121.651551 °		-121.651551 °
DWR ID						
Comment Code						
Inspector Comment						
FS_ID:18945 DS_ID:21047 EP_NO: N/A Repair Type: Non-Urgent Crossing Status: Found UCIP Comments: Need to determine owner of structure. Recommend removing vegetation along pipe alignment to conduct proper inspection of structure and appurtenances. FIELD_STRUCT_DESC: 16-inch steel pipe through the levee, 3.3 feet below the crown. Gate valve and switch box on landward slope. Pipe exposed on both slopes. (USACE-1959) Riprap on waterward side. This entry matches the Drainage or Irrigation Structure referenced in O&M manual (HLM 2.70). FS Date: 6/7/2013

Overview of waterward side. Pipe is mostly buried through waterward side.

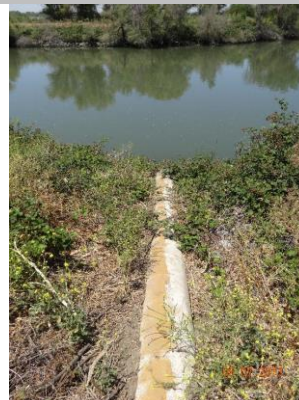
Photo 3 of 3 : UCIP\_SP\_2017\_18945\_31608.jpg

Exposed section of pipe located on waterward side.

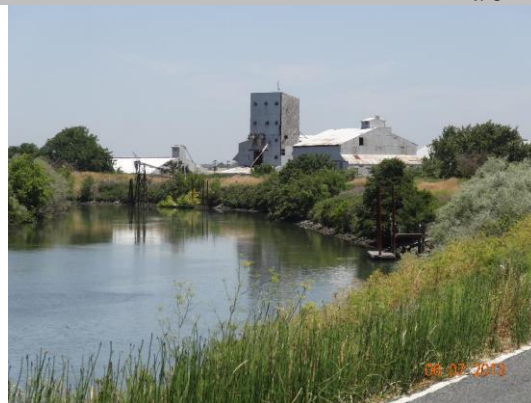
Photo 1 of 3 : UCIP\_SP\_2017\_32538\_58994.jpg

Comment Code					
Inspector Comment					
FS_ID:32538					
DS_ID:21048					
EP_NO: N/A					
Repair Type: Non-Urgent					
Crossing Status: Found					
UCIP Comments: Dense vegetation limits the inspector's visibility to identify signs of pipe failure (leaks) through the waterward slope. Recommend removing vegetation along pipe alignment to conduct proper inspection of structure and appurtenances. Need to find owner of crossing and determine if permit number is available.					
FIELD_STRUCT_DESC: 12-inch steel pipe through the levee, 5.0 feet below the crown. Pump on pile structure in stream. Service pole on landward slope. Concrete standpipe at landward toe. (USACE-1959). This entry matches the Drainage or Irrigation Structure referenced in O&M manual (HLM 3.80).					
FS Date: 6/7/2013

Photo taken downstream of structure.

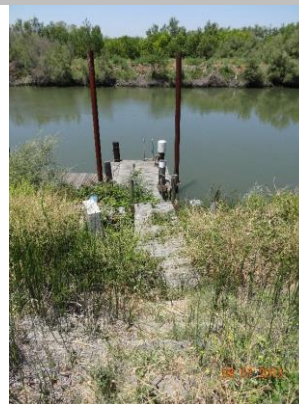
Photo 2 of 3 : UCIP\_SP\_2017\_32538\_58999.jpg

View of waterward side. Dense vegetation throughout waterward side.  
Walkway visible and support piles.

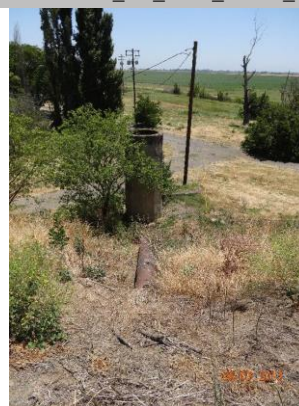
Photo 3 of 3 : UCIP\_SP\_2017\_32538\_58998.jpg

Item	DWR UCIP Field Study			38.266187 °	38.266187 °	
				-121.641909 °	-121.641909 °	
DWR ID						
Comment Code						
Inspector Comment						
FS_ID:32538						
DS_ID:21048						
EP_NO: N/A						
Repair Type: Non-Urgent						
Crossing Status: Found						
UCIP Comments: Dense vegetation limits the inspector's visibility to identify signs of pipe failure (leaks) through the waterward slope. Recommend removing vegetation along pipe alignment to conduct proper inspection of structure and appurtenances. Need to find owner of crossing and determine if permit number is available.						
FIELD_STRUCT_DESC: 12-inch steel pipe through the levee, 5.0 feet below the crown. Pump on pile structure in stream. Service pole on landward slope. Concrete standpipe at landward toe. (USACE-1959). This entry matches the Drainage or Irrigation Structure referenced in O&M manual (HLM 3.80).						
FS Date: 6/7/2013

View of landward side--section of pipe exposed and Standpipe.

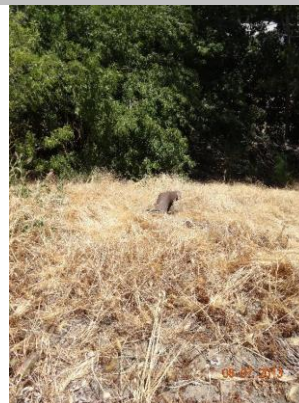
Photo 1 of 3 : UCIP\_SP\_2017\_46768\_30382.jpg

Comment Code					
Inspector Comment					
FS_ID:46768 DS_ID:21049 EP_NO: 1557 Repair Type: Non-Urgent Crossing Status: Found UCIP Comments: Crossing appears abandoned--wooden platform structure appears to be abandoned on waterward side. Small hole underneath pipe on landward side--unable to determine cause (rodent/pipe leak) Need to find owner of crossing to determine status. Recommend removing vegetation along pipe alignment to conduct proper inspection of structure and appurtances. FIELD_STRUCT_DESC: *ABANDONED* 6-inch pipe through the levee, 2.5 feet below the crown. Pump in pump house on waterward slope. (USACE-1959). This entry matches the Drainage or Irrigation Structure referenced in O&M manual (HLM 3.90). Permit No. 1557, 1951). FS Date: 6/7/2013

View of landward side showing a small section of pipe exposed.
